Manhole Inspection Summary

Manhole # S55K__055MH

Insp Date: **6/2/08 10:19 AM**

Location Address: **3710 foster ave**

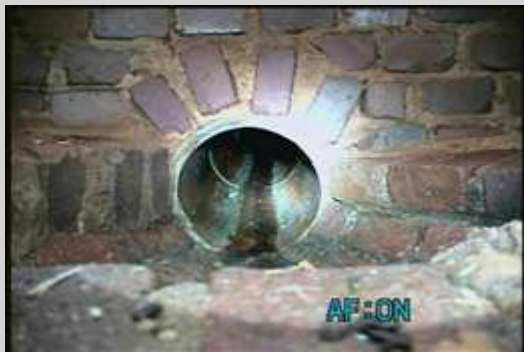
12 O'Clock Outflow

Invert Depth: **10.20** (ft.) Flow Characteristics: **Slow**

Deposits: ☒ None ☐ Mud ☐ Sludge ☐ Debris ☐ Grease

Infiltration: **None** Pipe Seal Cond: **Unknown**

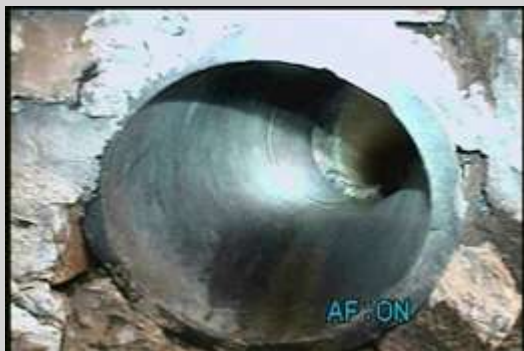
3 O'Clock Inflow

Invert Depth: **4.70** (ft.) Flow Characteristics: **Slow**

Deposits: ☒ None ☐ Mud ☐ Sludge ☐ Debris ☐ Grease

Infiltration: **None** Pipe Seal Cond: **Unknown**

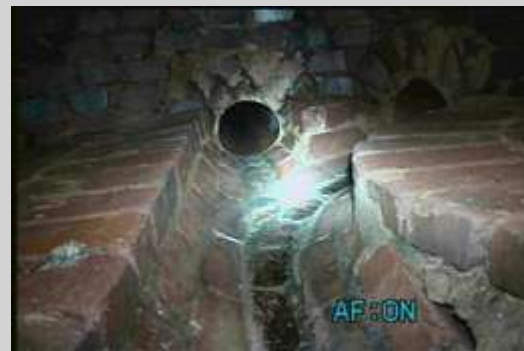
Drop In @ 3 O'Clock

Drop: **Outside Direct**

Inv Depth: **9.90** (ft.)

Drop Condition: **Open**

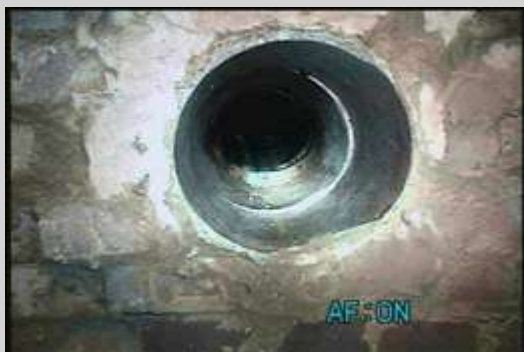
Pipe In @ 9 O'Clock

Invert Depth: **7.40** (ft.) Flow Characteristics: **Slow**

Deposits: ☒ None ☐ Mud ☐ Sludge ☐ Debris ☐ Grease

Infiltration: **None** Pipe Seal Cond: **Unknown**

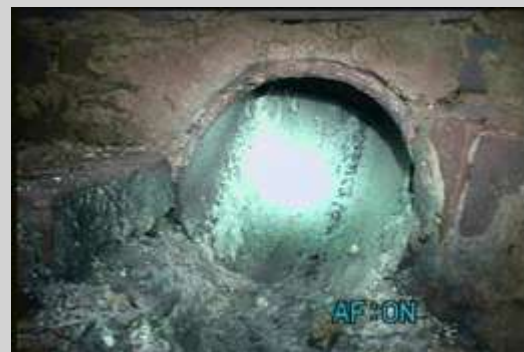
Drop In @ 9 O'Clock

Drop: **Outside Direct**

Drop Condition: **Open**
